Manhole Inspection Summary

Manhole # S51K__038MH

Insp Date: **4/1/08 8:07 AM**

Location Address: **rear 701 s. curley st**

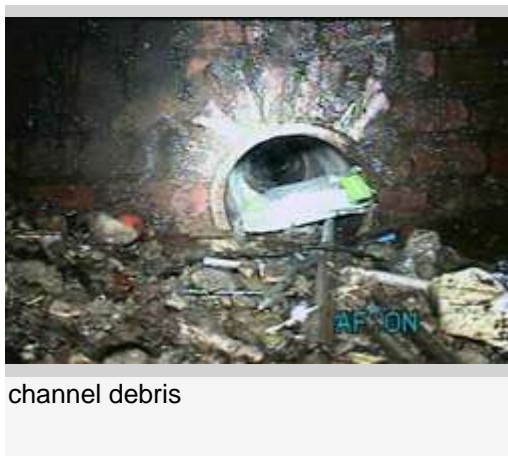
Defect 4

☒ **Debris**

channel debris

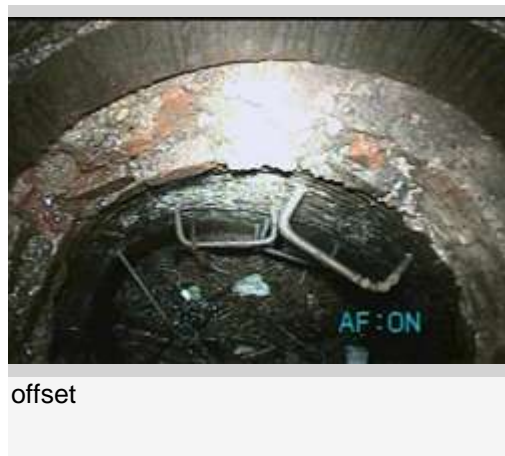
Defect 3

Offset: **4** (in.)

offset

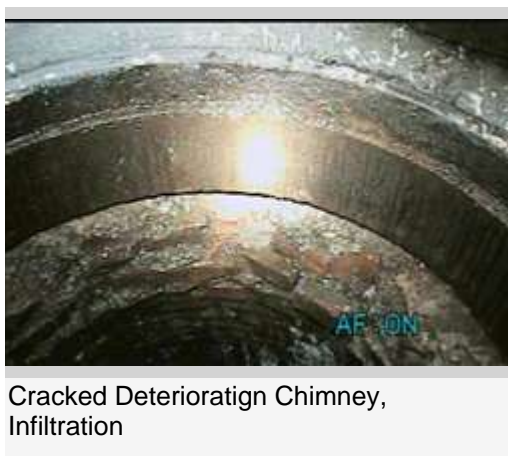
Defect 1

☒ **Deteriorated**

☒ **Wall**

Cracked Deterioratign Chimney,
Infiltration

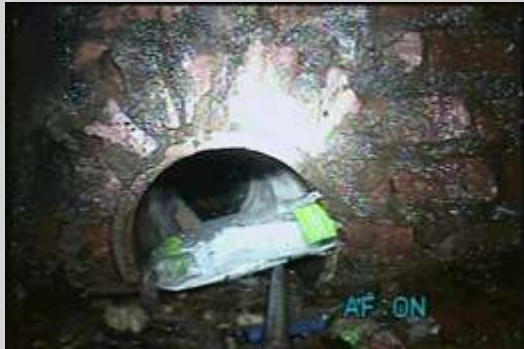
12 O'Clock Outflow

8 in. Circular Gravity Sewer
Pipe Out @ 12 O'Clock

Deposits: ☐ None ☐ Mud ☐ Sludge ☒ **Debris** ☐ Grease

Silt Depth: **3** (in.) Deposits Extent: **Medium**
